Erosion and Accretion Trends Along the Lake Michigan Shore at North Point Marina and Illinois Beach State Park

**Year-2 (1996) Report of a Four-Year Study of Coastal Geology and
Coastal Geologic Processes**

Illinois State Geological Survey
Coastal and Wetlands Geology Section
615 E. Peabody Drive
Champaign, Illinois 61820-6964

May 1997

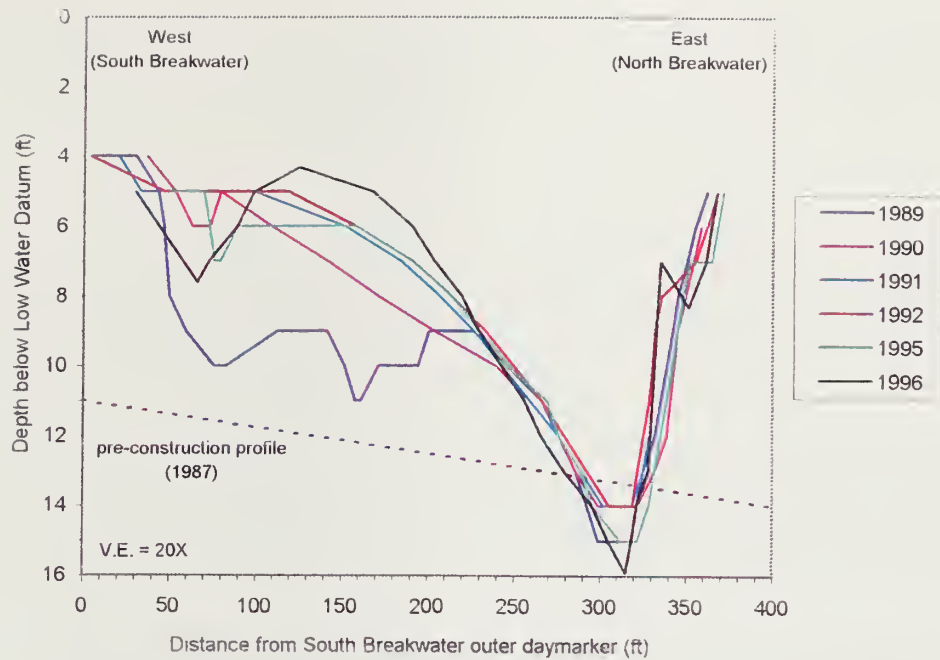
Figure 3-7 Cross-sectional profiles at the entrance to North Point Marina. The profiles extend between the tips of the north and south breakwaters and illustrate the asymmetric bathymetric cross-section that has persisted since 1989. Index map shows profile location and the boundary limits used for annual volume-change calculations. The 1996 bathymetric data were collected in June 1996 during dredging. Continued dredging through August 1996 probably increased water depths on the western side of the entrance.

1996 bathymetry was similar to the 1995 bathymetry. An asymmetric lake-bottom profile, first documented in 1989, was still present in 1996 between the tips of the north and south breakwaters (Fig. 3-7). The northeastern side of the marina entrance remained deeper than the southeastern part, with a 10-ft deep trough extending northwestward towards the commercial basin (Fig. 3-8). Adjacent to the tip of the north breakwater, the trough deepened to 16 ft LWD, about 1 ft deeper than it was in 1995. The lake bottom at this locality was about 1 ft below the design elevation for the base of the north breakwater.

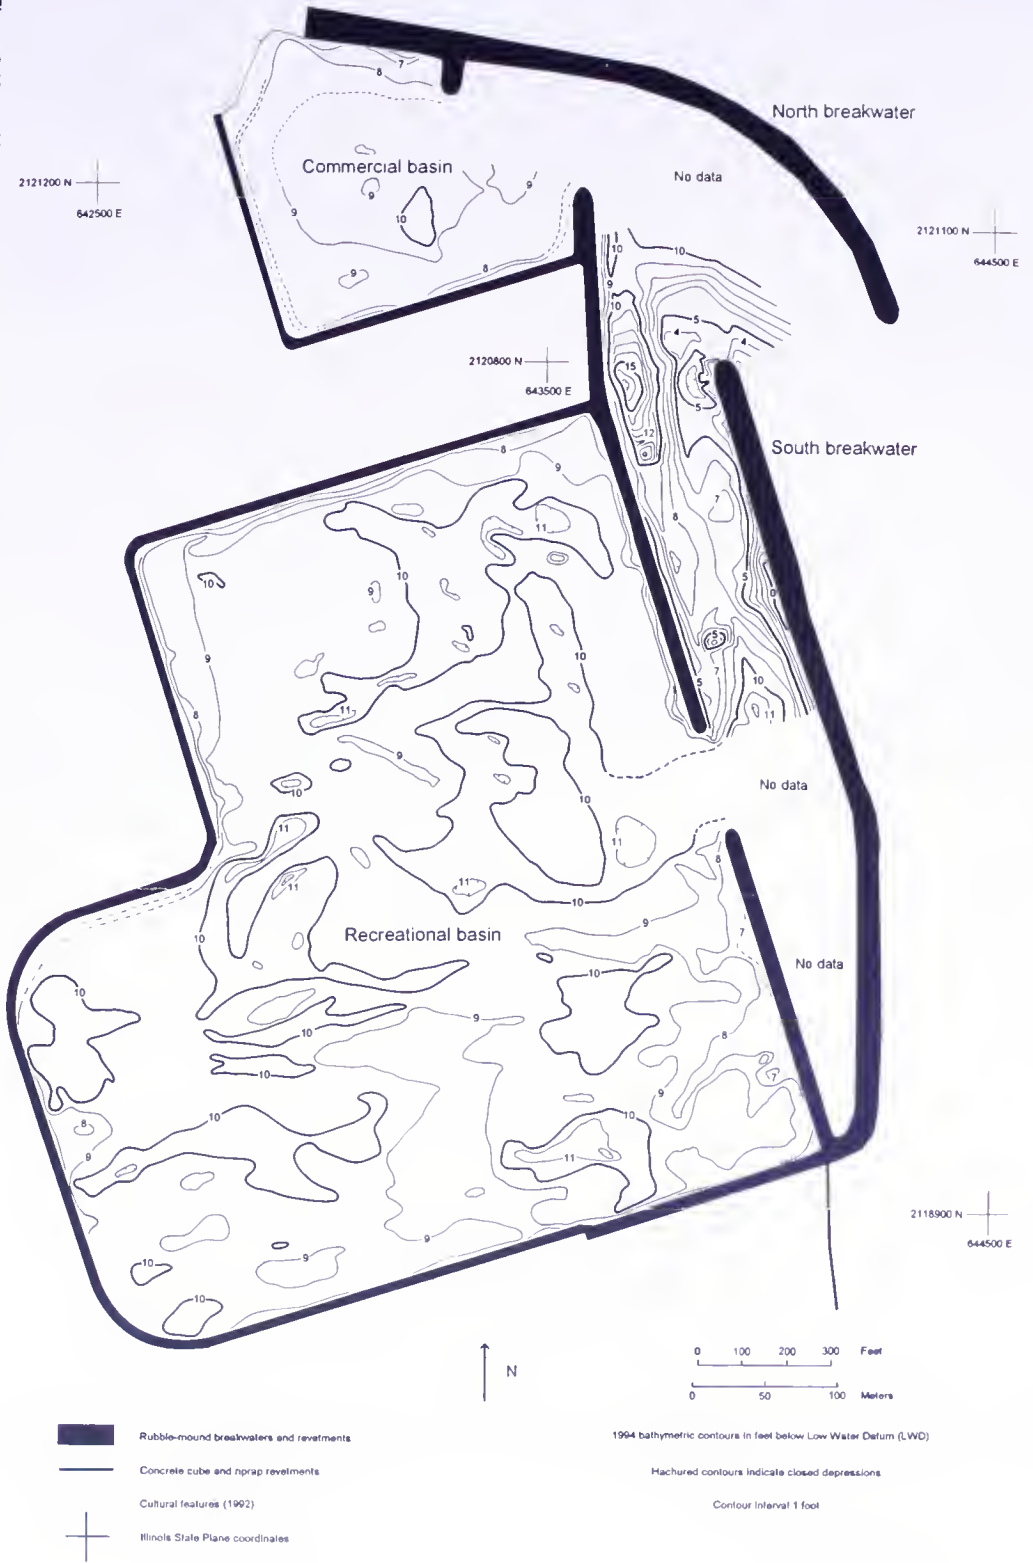
Figure 3-11 1996 bathymetry in the North Point Manna basins and approaches. Data from ISGS surveys in summer and autumn 1996.

In the approach channel to the recreational basin, water depths generally ranged between 4 and 10 ft LWD. The maximum recorded depth of just over 19 ft LWD occurred at the elongate trough adjacent to the north inner breakwater due west of the tip of the south breakwater. A second elongate trough was mapped at the entrance to the recreational basin and had a maximum recorded depth of 13.8 ft LWD. Four small isolated topographic highs in the approach channel had crest elevations of just under 6 ft LWD.

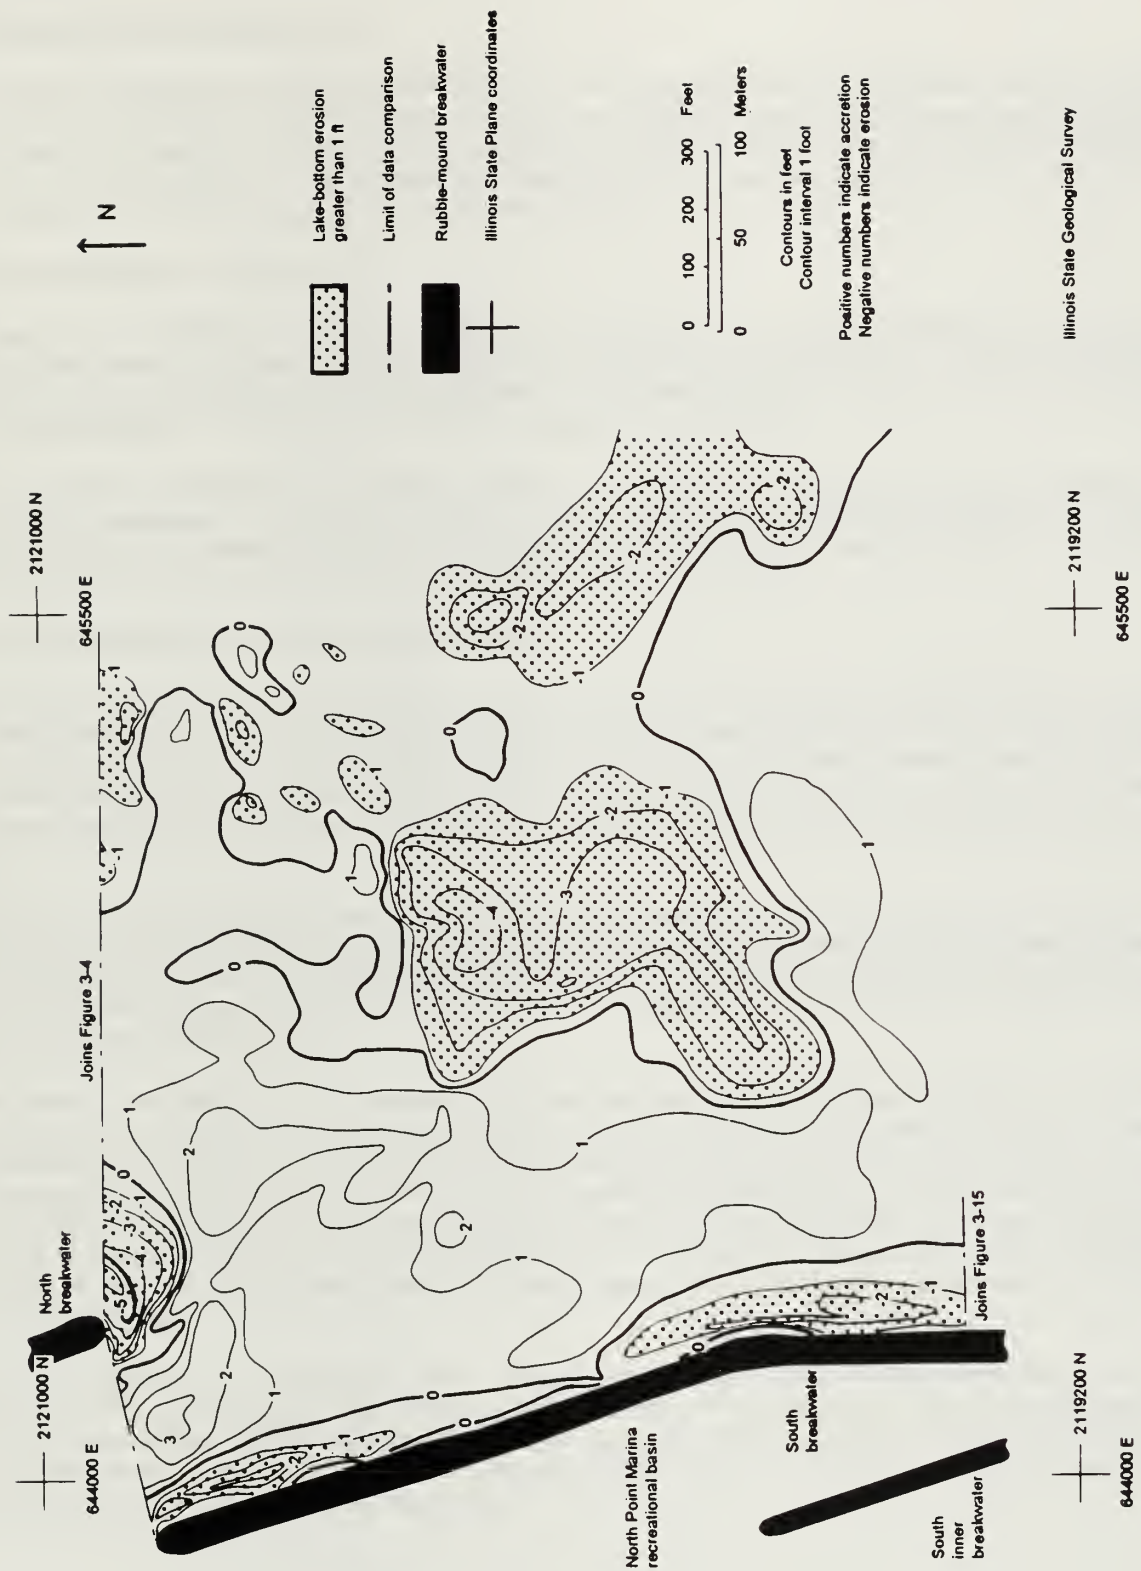
Figure 3-13 1995-1996 lake-bottom change in the south breakwater nearshore.

Accretion Accretion occurred primarily along a single accretional zone centered approximately 300 ft offshore of the south breakwater in water depths of 8 to 15 ft LWD (Fig. 3-13). This feature appears on the 1996 bathymetric map (Fig. 3-12) as a lakeward deflection of the 10-ft LWD isobath along the northern half of the south breakwater. The northern tip of this accretional lobe extends westward towards the marina entrance where 3.5 ft of accretion occurred between 1995 and 1996 (Fig. 3-13). At the south end of the accretional lobe, the lake bottom shallowed by 1 ft between 1995 and 1996.

Erosion Erosion in excess of 1 ft occurred in three principal areas. (1) Along a narrow strip within 50 to 100 ft of the south breakwater, the lake bottom generally deepened by about 1.5 ft, locally deepening by 3 ft near the north tip of the south breakwater. (2) Deepening up to 6 ft occurred within 200 ft of the tip of the north breakwater. This erosional area extends into the marina entrance and is the southernmost part of the erosional trough that extends across the North Beach / north breakwater nearshore (Fig. 3-4). (3) Up to 4 ft of erosion occurred in water depths greater than 15 ft LWD in a broad area located 400 to 1600 ft offshore of the bend in the south breakwater.

The inner part of the south breakwater nearshore appears to have trapped a volume of sediment just greater than that lost from the North Beach / north breakwater nearshore (Fig. 3-4). The accretional lobe defined by the 1-ft lake-bottom change contour in Fig. 3-13 contains 23,200 cu yds of sand. The location and orientation of the lobe suggest that the sediment it is comprised of was derived largely from the erosional trough in the North Beach / north breakwater nearshore. The lobe is about three times the volume of a similar accretional lobe that developed in the same area during 1992-1995 (Foyle *et al.*, 1996). The presence of the lobe indicates that the marina is not a total barrier to littoral sediment transport. The presence of the lobe also suggests that the material lost from the North Beach / north breakwater nearshore during 1995-1996 was deposited a short distance downdrift in the south breakwater nearshore.

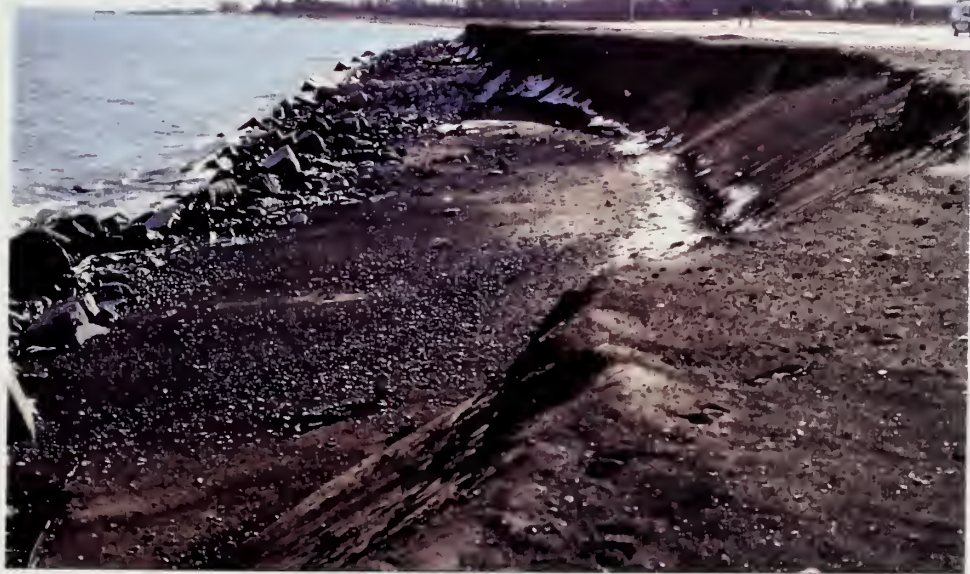
Figure 3-17 Photograph showing the riprap-defended shoreline and erosional embayments in the sand and gravel backfill along the NPM south parking area. The scarp height is approximately 11 ft, and up to 50 ft of scarp recession has occurred since January 1996 when the scarp lay along the line of riprap (left side of photo). View is to the south from a point due east of the southernmost keyed-access parking lot gate. The Camp Logan headland is visible in the background (Photo date November 21, 1996).

- 6) Planned shore defense along the south parking area nearshore, currently under review by state and federal agencies, must account for ongoing and annually variable lake-bottom erosion in this area. At the site of the proposed offshore submerged breakwater, the rate of lake-bottom deepening during 1995-1996 was four to six times greater than that documented during 1992-1995. Based on ongoing lake-bottom erosion at this site, and the increased rate of lake-bottom erosion during 1995-1996, post-construction monitoring at this site is recommended.

Storms during late summer and autumn of 1996 caused renewed erosion along the south parking area and redevelopment of the embayments. During November 1996, the erosional scarp defining the landward limit of these embayments was up to 11 ft high and at one location was located as little as 45 ft east of the parking-area access road.

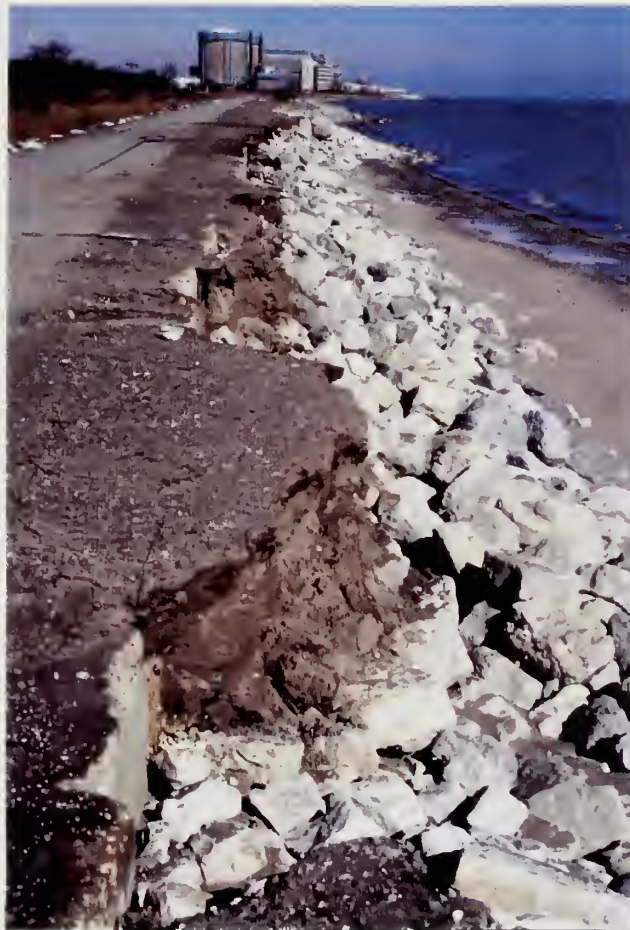
Figure 3-22 Photograph showing the south end of the IBSP/SU beach-nourishment site. A precipitous drop-off exists between road level and the adjacent riprap and beach. For scale, the concrete cubes in the foreground along the east side of the access road measure 3 ft by 4 ft by 4 ft. View is to the north with the Zion Nuclear Power Plant in the background (photo date February 25, 1997).

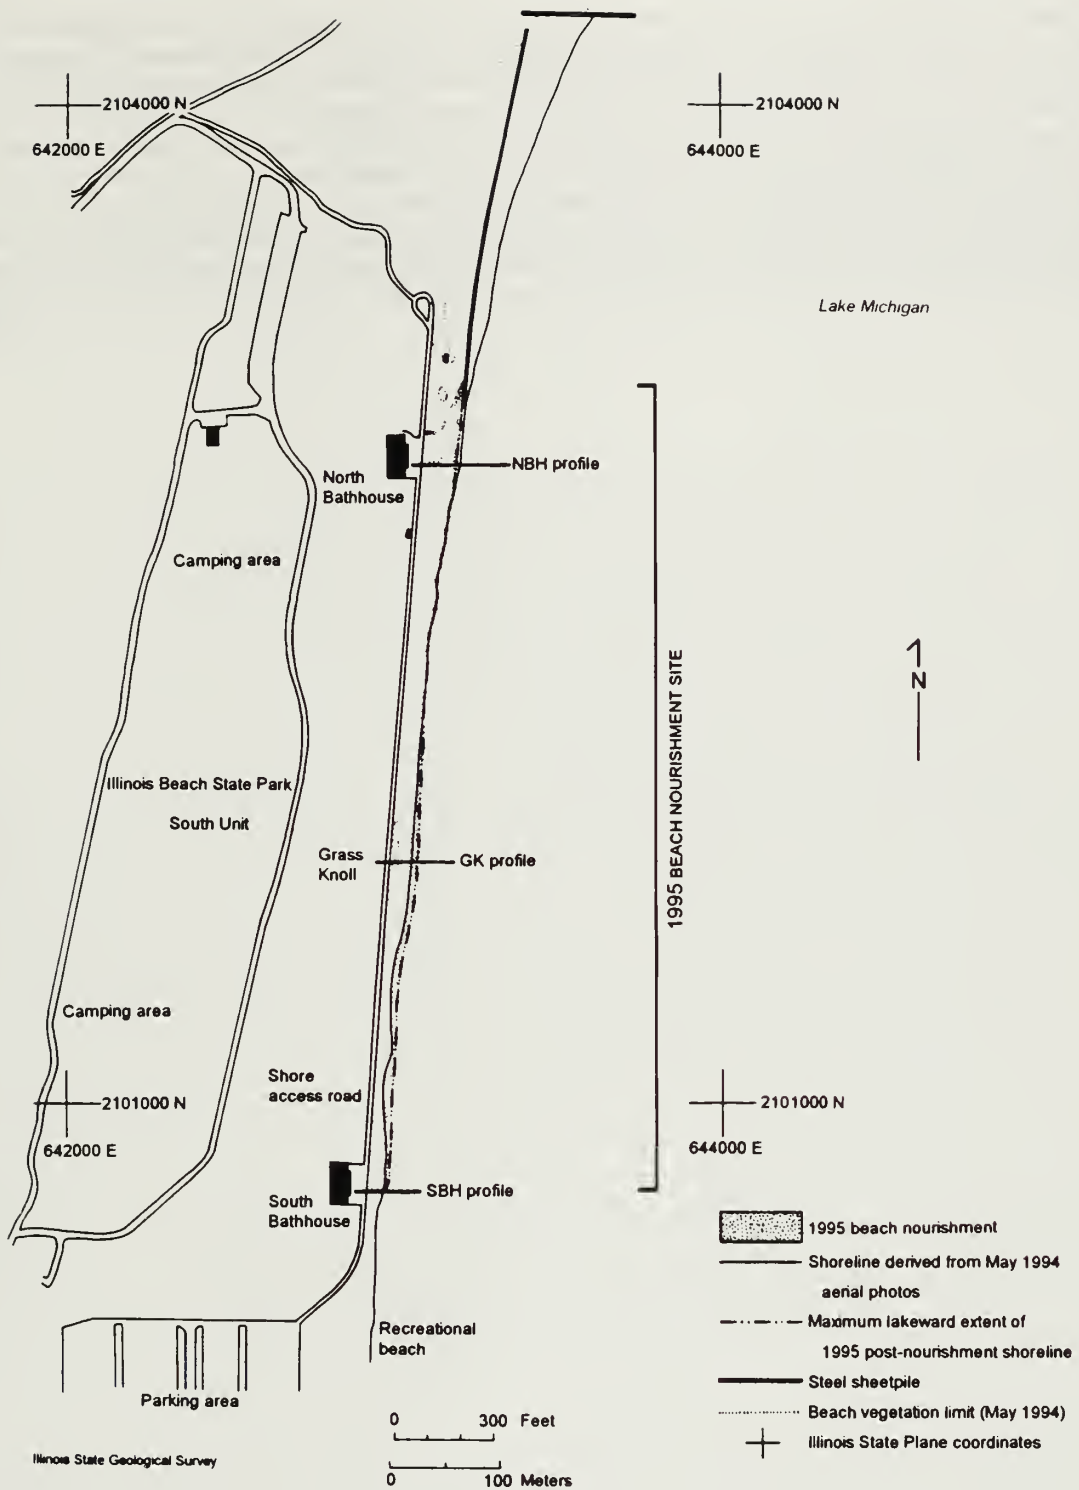
Figure 3-23 Location of the 1995 beach-nourishment site in the South Unit of Illinois Beach State Park.
